## Bar Flex and Heli Pile Repair For Garden Retaining Wall

At the request of Borough Council Engineers Target surveyed this site to establish the causes of this failure and provided a cost effective solution utilising the Heli Pile and Bar Flex systems.

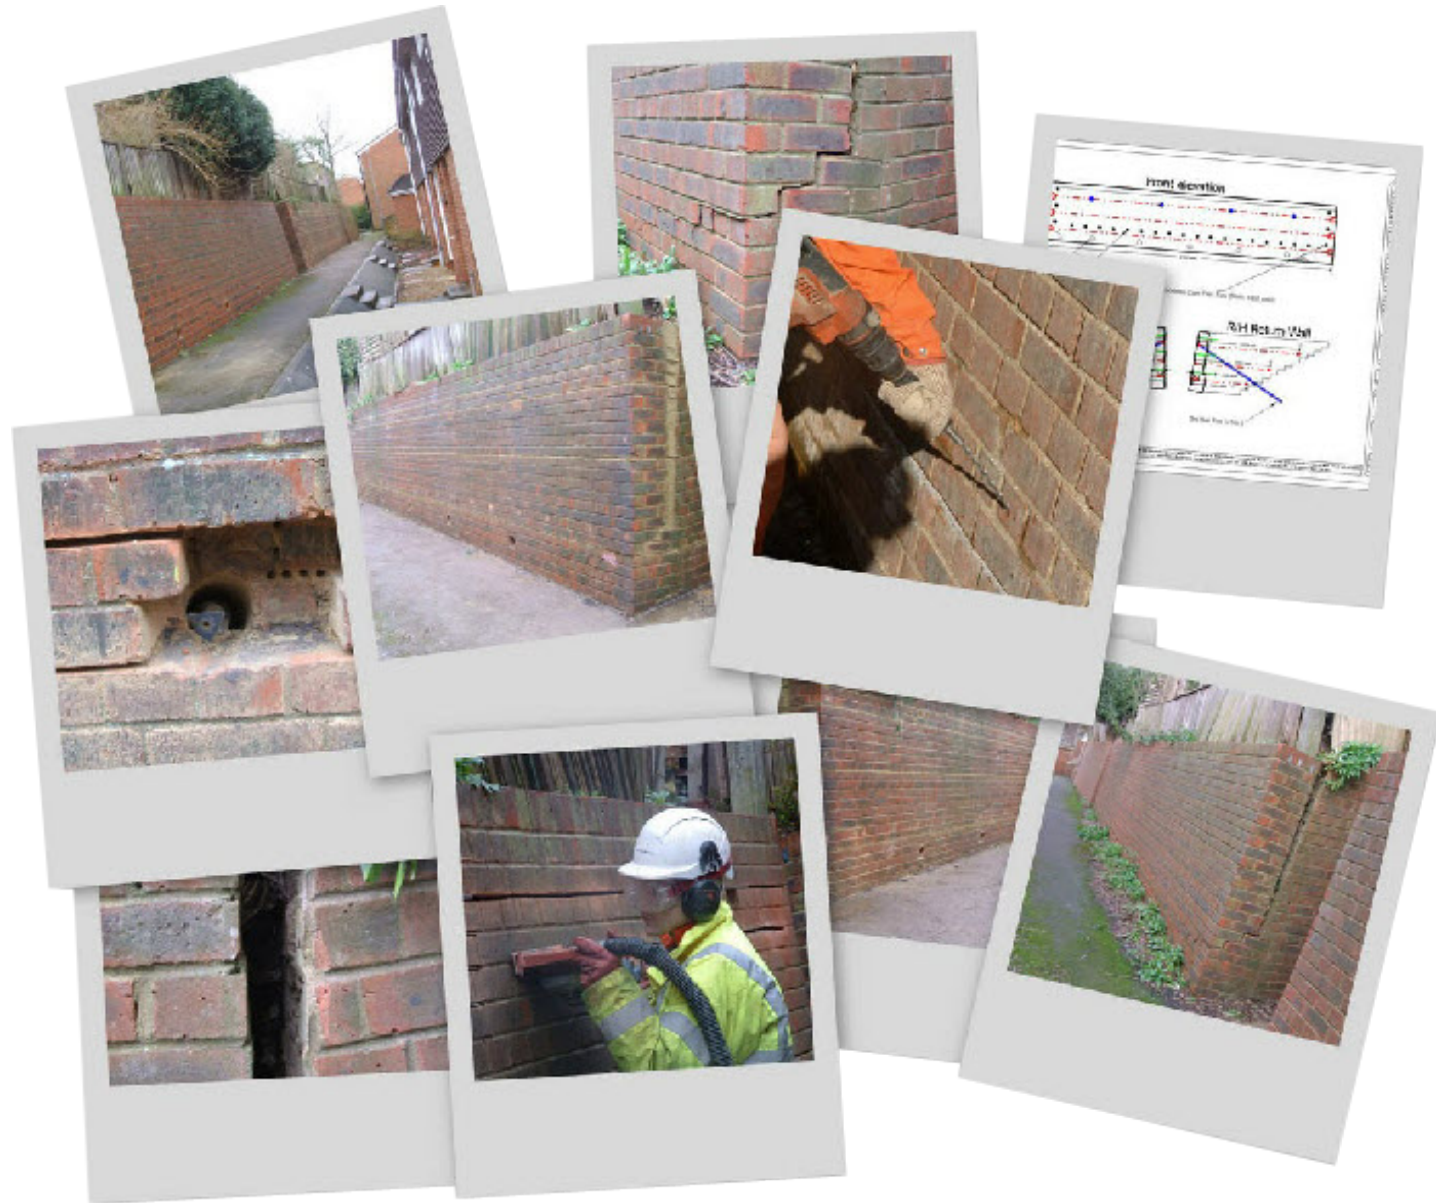
Although the wall had been built with sufficient weep holes they were not working. This allowed an excessive build up of water pressure every time it rained. The fact that the wall was originally built "battered" back was probably the only reason it hadn't totally failed. From foundation level to 6 courses above ground the wall is 18" thick and is toothed in at the corners. Above this point the wall thickness reduces to 13.5", it was at this point that the wall was rotating.

Where the Heli Piles were to be installed bricks were removed and holes cored through the remainder of the wall allowing the installation of the Heli Piles. Slots were cut in the bed joints at the same level allowing the Bar Flex reinforcement to be installed and mechanically connected to the Heli Piles. The brick that had previously been removed were cut into slips and replaced leaving an invisible repair. All Heli Piles work in both tension and compression and are all proof tested in-situ on site.
