Bar Flex & Heli Pile Repair

For Garden Retaining Wall.

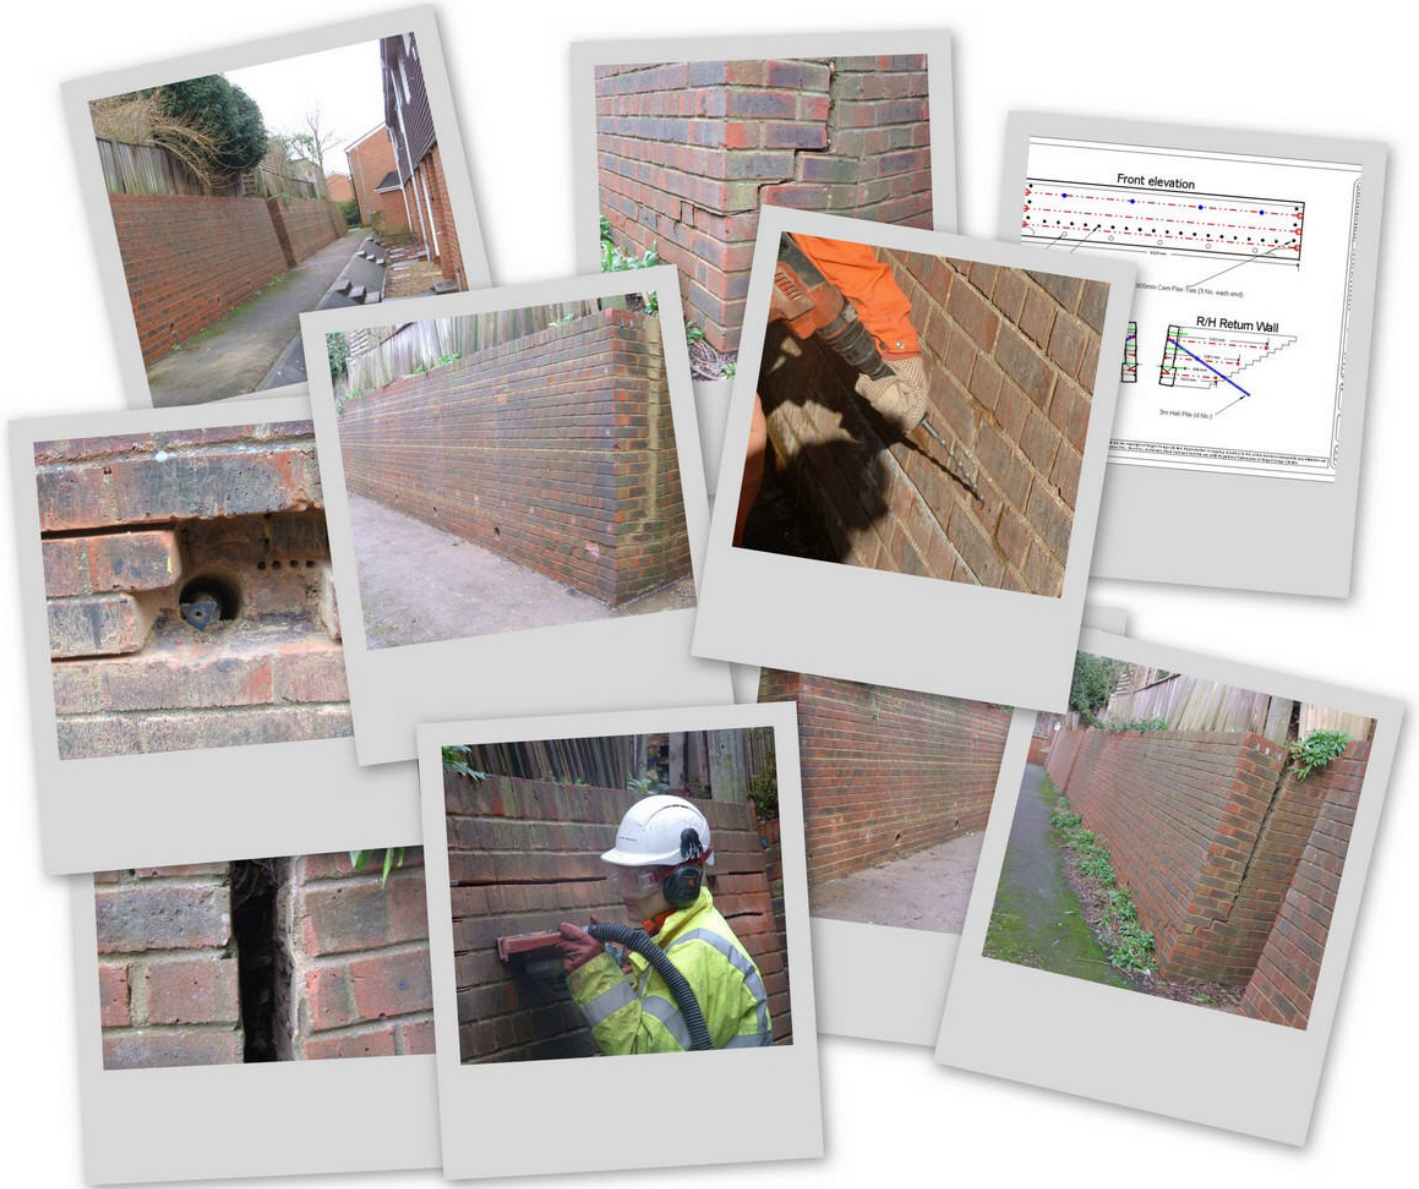
Although the wall had been built with sufficient weep holes they were not working. This allowed an excessive build up of water pressure every time it rained. The fact that the wall was originally built “battered” back was probably the only reason it hadn’t totally failed. From foundation level to 6 courses above ground the wall is 18” thick and is toothed in at the corners. Above this point the wall thickness reduces to 13.5”, it was at this point that the wall was rotating.

Where the Heli Piles were to be installed bricks were removed and holes cored through the remainder of the wall allowing the installation of the Heli Piles. Slots were cut in the bed joints at the same level allowing the Bar Flex reinforcement to be installed and mechanically connected to the Heli Piles. The brick that had previously been removed were cut into slips and replaced leaving an invisible repair. All Heli Piles work in both tension and compression and are all proof tested in-situ on site.
