## Bar Flex & Retro Flex

## High Rise Structural Repair

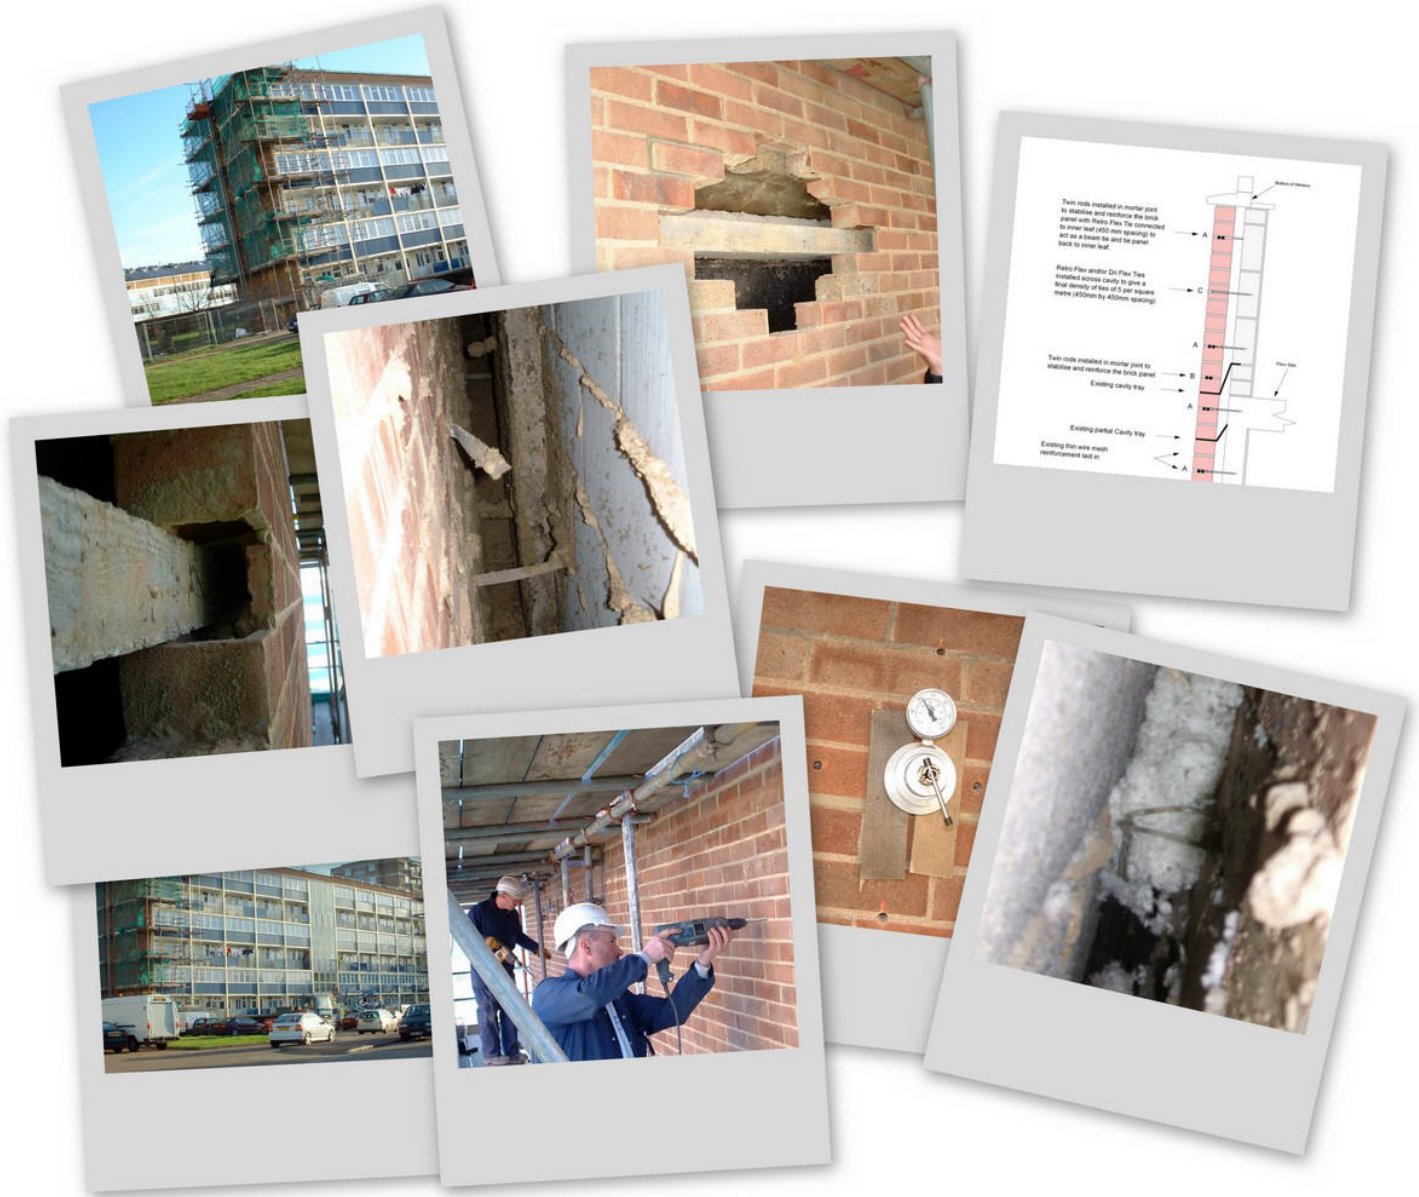
The original inner leaf had been replaced years ago and any wall ties that didn't align with the new coursing were just bent back without additional ties being installed. In addition, the brick panels between the floors of the six storey structure had continued to expand whilst being restrained between the concrete floor nibs. This had caused the panels to bow and force the slip bricks away from the nibs. At third floor level the brick panels and slips had bowed outwards by about 50mm.

By introducing the Bar Flex into the bed joints along with its bonding agent Bond Flex the masonry became a reinforced panel as was able to span horizontally between the vertical concrete columns. The floor nibs were extended utilising the existing slip bricks and the introduction of Retro Flex ties and Bond Flex grout. Movement joints were then cut in calculated positions to eliminate the existing problem and remove any chance of reoccurrence.
